PRODUCT INSPECTION & SAFETY NOTICE

CAPTO 11 mm Gray and CAPTO 13 mm Red

Part #: 336011 & 336013 all versions

Issue: Cam Set Screw Thread Locker

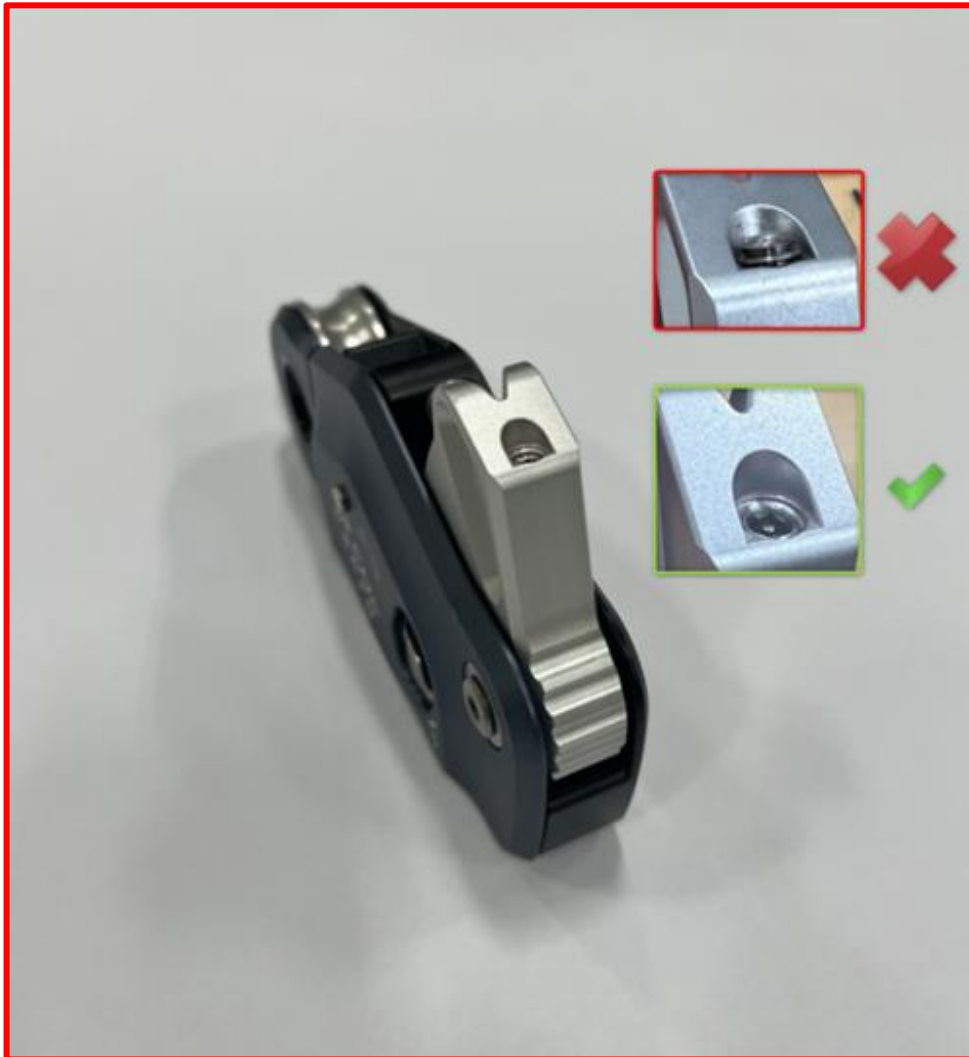
1. Verify there are no exposed threads on the cam screw. The set screw should be flush or slightly below the pocket (see Figure 1). If there are any exposed threads, this is unacceptable.
2. Check the cam function. Ensure that it moves freely when actuated by hand and returns to the closed position when released. If the cam function is impeded, or does not close properly, this is unacceptable.

(Figure 1: Correct and Incorrect Cam Screw Height)

Inspect your CAPTO unit and remove it from service immediately if it does not pass any of the following:
