Product Information Notice 11mm CMC™ CLUTCH™ by HARKEN INDUSTRIAL™

August 18, 2020 Part Number: 335011

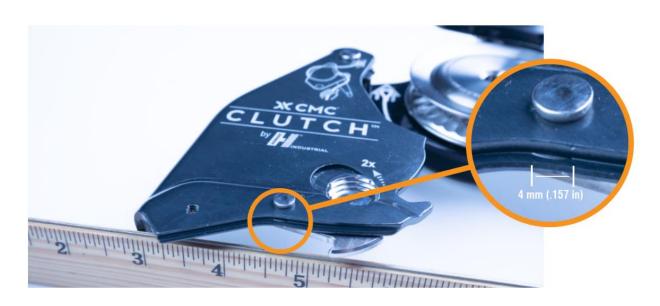
This discrepancy presents as a discolored sliver or gap in the Moving Side Plate approximately 4mm (0.157in) in length as shown in the photos below. The area in question is only visible when the Moving Side Plate is open and remains hidden when the CLUTCH is in use.

CMC performed standard Quality Control and functional product testing to confirm no impact to safety, performance, function, or strength for affected units. All CLUTCH units that have this cosmetic issue are within the design specifications and can remain in service. CMC and Harken Industrial are collaborating on a manufacturing process change to eliminate this cosmetic issue in future CLUTCH units.
